ROBERT SCHULTE DAM

MO 10497

PHASE 1 INSPECTION REPORT NATIONAL DAM SAFETY PROGRAM.

DECEMBER 1978

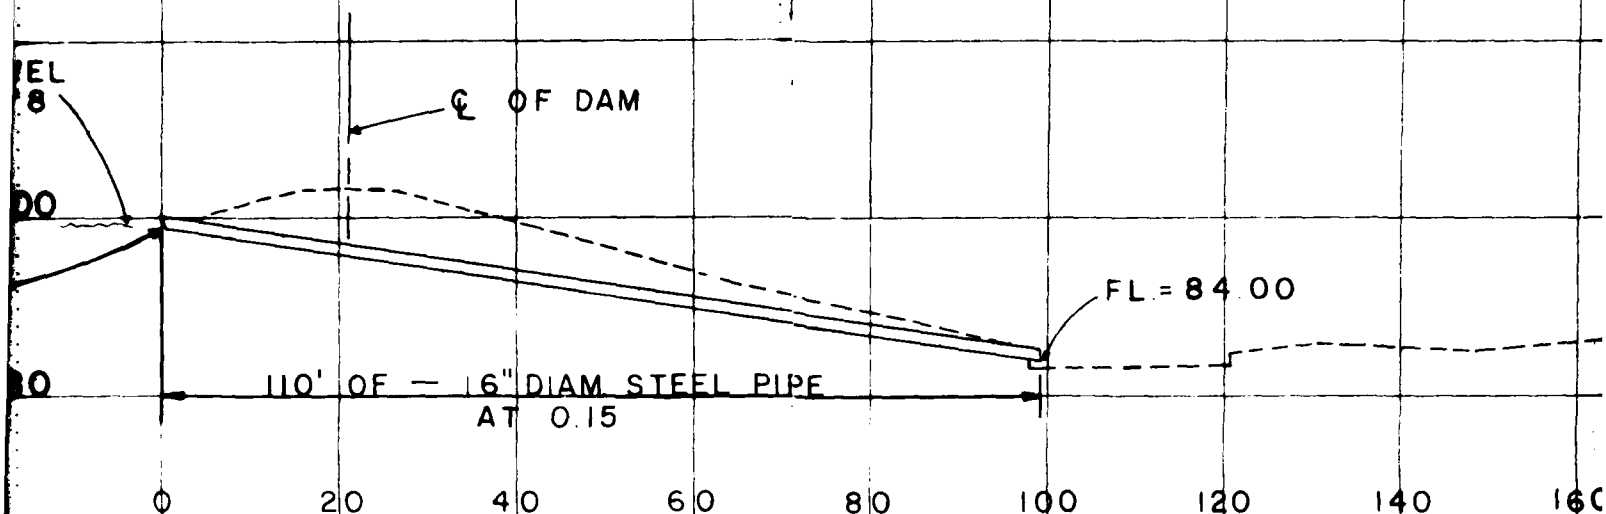
SECTION OF DAM
AT STA 3+00
SHOWING PRINCIPAL SPILLWAY PIPE

(a) Downstream - 1V on 3H (determined from section at Station 3+00, see Plate 3).

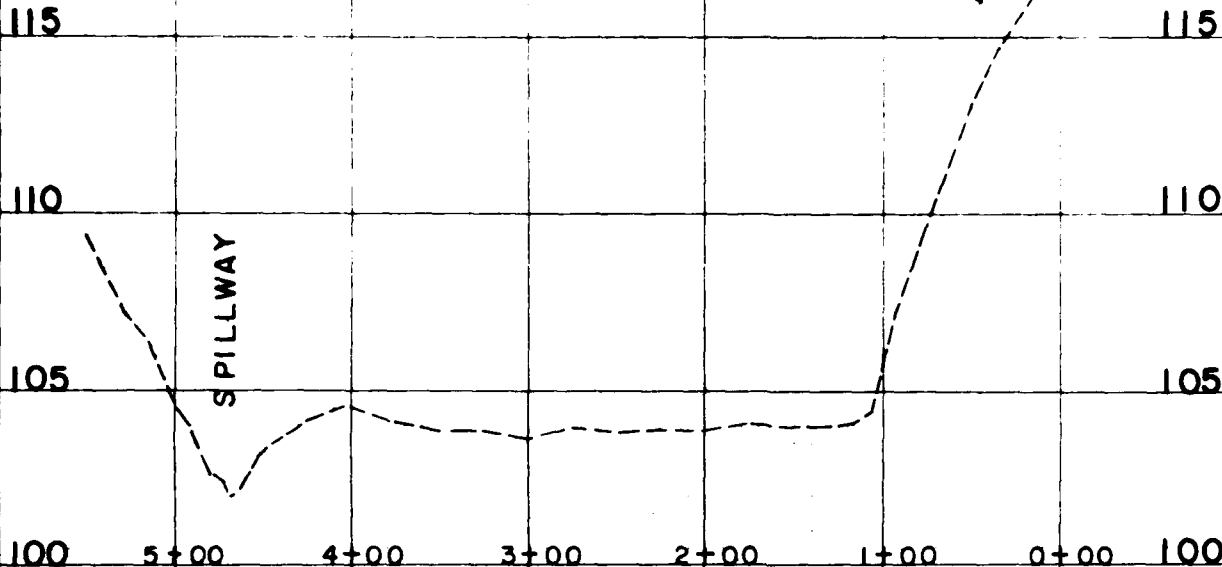
PROFILE OF TOP OF DAM

(1) Top of dam - 493.6 to 494.5 (see Plate 3).

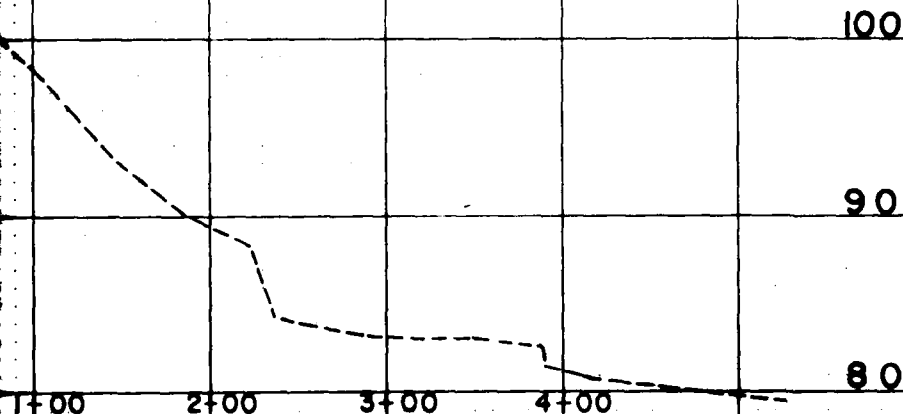
PROFILE OF EMERGENCY SPILLWAY

The emergency spillway for the dam is a broad, shallow swale at the east end (S-5, S-6, S-8); its capacity is relatively small. Visually, there appears to be an indication of a spillway on the west end (S-7); however, grades from surveys (See Plate 3) show it too high to be a spillway.
